RESIDENTIAL INSPECTION

123 Main St
Houston TX 77001

John Doe
DECEMBER 9, 2019

PROPERTY INSPECTION REPORT

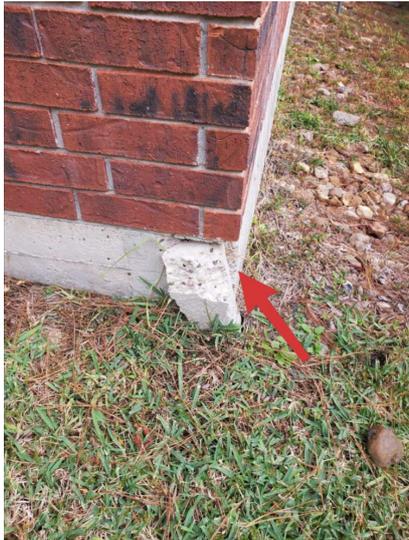
Corner pops are common with poured concrete slabs. While they may look bad, they are rarely a serious issue. This corner pop appears to be only cosmetic and does not appear to be affecting the structure of the foundation or the walls at all. I recommend monitoring the corners of the slab to ensure they don't get worse over time.

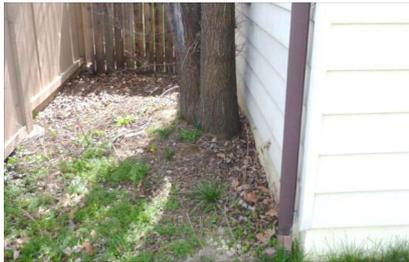
Trees Too Close to Foundation

Tree roots can cause serious damage to foundations and roofs, along with plugging up gutters. We recommend having trees removed that can lead to these expensive repairs.

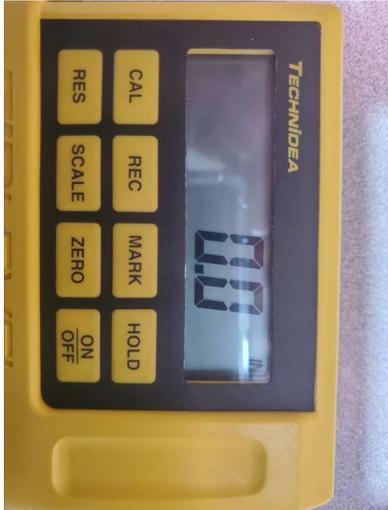
"0" reading at front of house and left side of house.

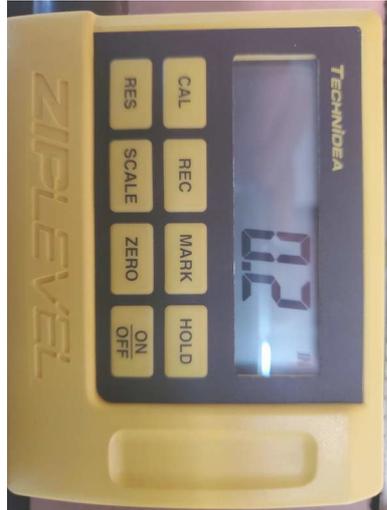
.2" of slope from left to right across entire foundation.

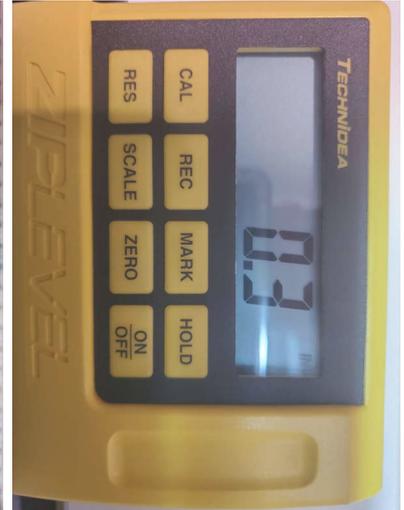
.3" rise from front of home to back across entire foundation.

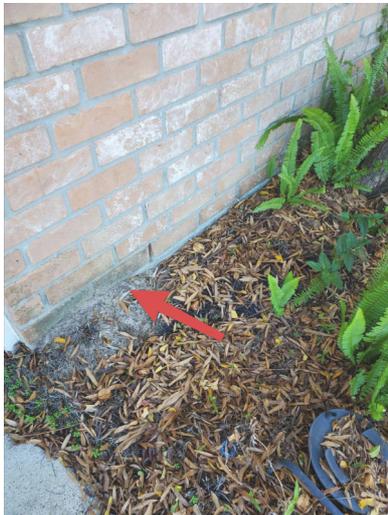
Insufficient Clearance from Foundation to Grade

It is recommended that there be a minimum of 4" of clearance from the foundation to the ground when brick siding is used. Having an improperly graded lot next to the property can lead to foundation damage and possible infestations. Recommend removing dirt from around the foundation.

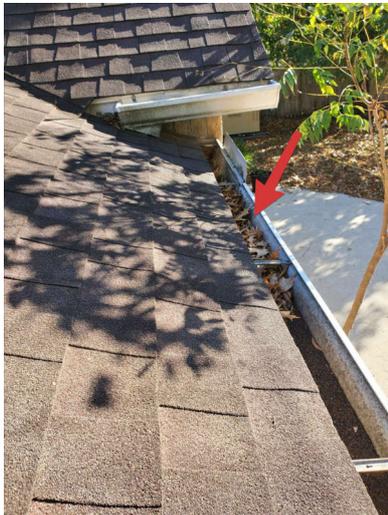
The gutters/downspouts were full of debris and leaves. If left in this state water can fill the gutters and damage the eaves of the roof. Water can also overflow the gutters and spill out directly next to the foundation, potentially causing damage.

The downspouts were discharging too close to the foundation. We recommend having water discharge a minimum of five (5) feet away from the foundation and directed to flow away from the foundation when leaving the downspout. If you are unable to route water discharge 5 feet away, at a minimum I recommend installing splash blocks under the downspout discharge to help direct water away from your foundation.

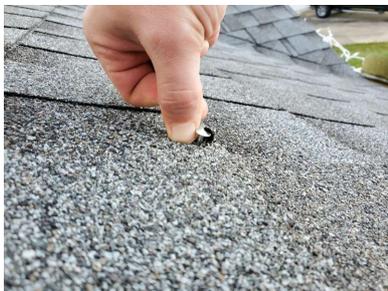
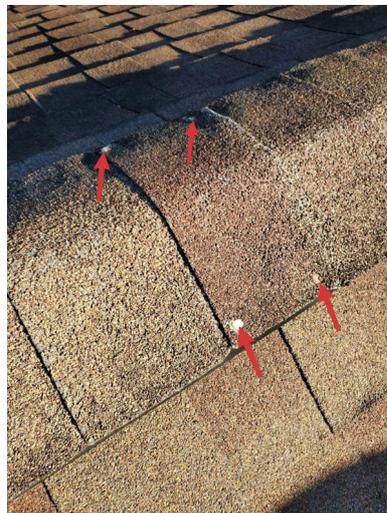
1: Exposed Nails

Under-driven or exposed nails were found in one or more roof coverings. This can lead to water intrusion which can cause rot, mold, structural and cosmetic damage. I Recommend a qualified roofer evaluate and correct.

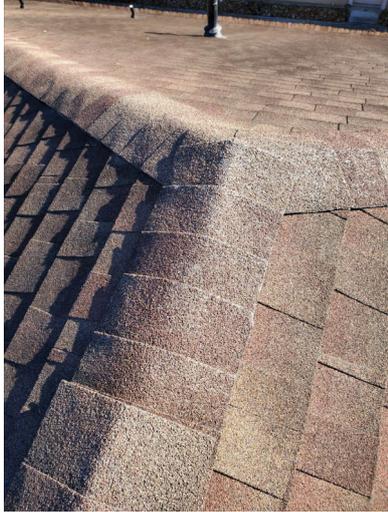
2: Loss of granules.

Asphalt shingles are showing signs of granule loss. This is typical for a roof this age. Recommend monitoring.

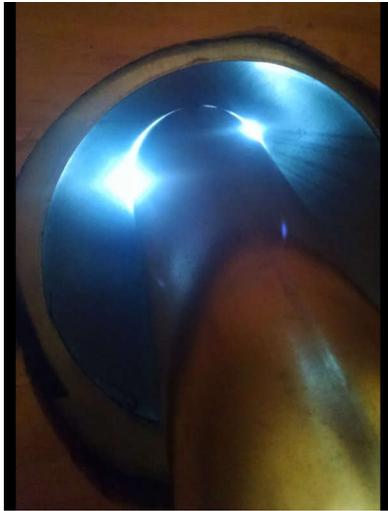
3: Roof penetrations not properly sealed.

The water heater flue piping was not properly sealed around the storm collar as shown by light coming through into the attic. I recommend having a qualified roofing contractor evaluate and repair.

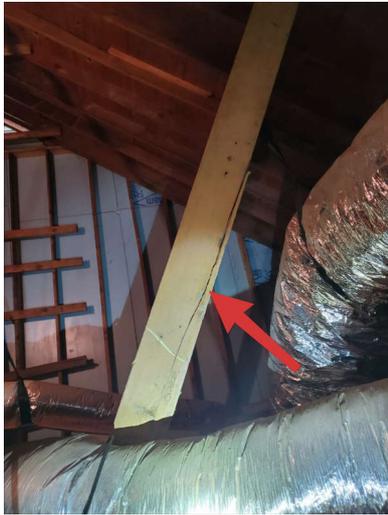
1: Purlin brace is cracked

A purlin in the attic had a significant crack running through it's length. Purlins are designed to provide support for the roof structure and cracked purlins could significantly reduce the support of the roof structure. I recommend having a qualified contractor evaluate the roof framing and correct this issue.

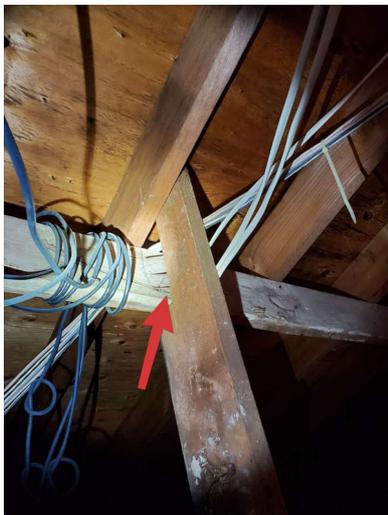
2: Purlin brace pulling away from purlin.

Purlin braces are required to be firmly attached to purlin. This brace has pulled away from the purlin, indicating possible movement of the roof structure.

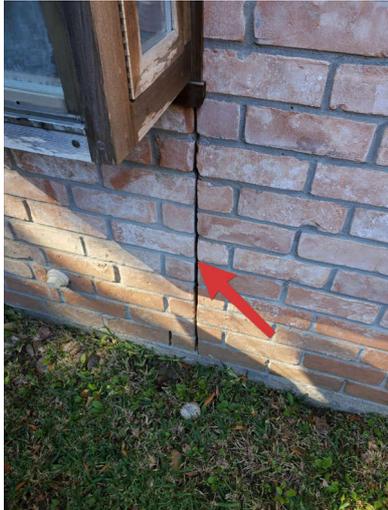
Expansion joint not caulked :

The expansion joint in the wall was not caulked. This can lead to water intrusion and possibly damage. I recommend caulked all expansion joints as this is a cheap way to help ensure water doesn't enter your walls.

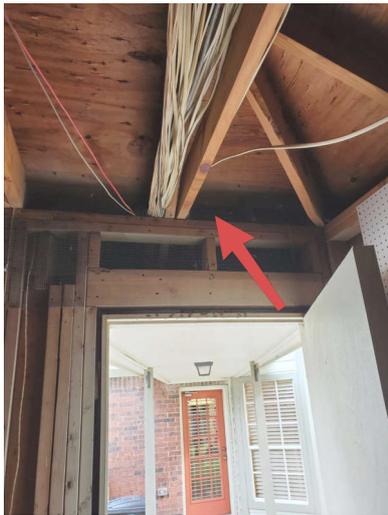
1: No fireblocking in breezeway from garage to house.

Fireblocking is required in detached garage breezeway to prevent a garage fire from spreading to the main house. This is a very important issue that should be resolved immediately. Due to how houses are designed to naturally draft air through the attic, if a fire starts in the garage it will be pulled through the breezeway and into the attic. This can be easily and cheaply avoided by installing a fire blocking material at the garage.

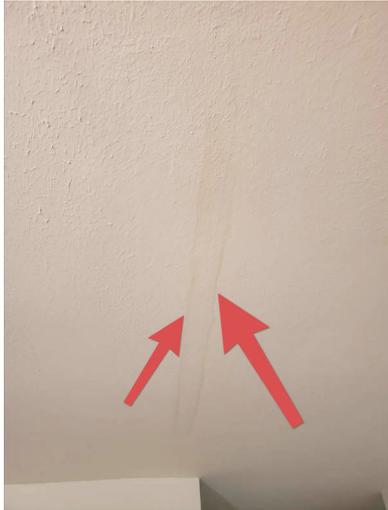
1: Ceiling - Recent Roof Leak Damage

Stains on the ceiling appear to be the result of roof leaks. The source of leakage should be identified and corrected, and the ceiling re-painted.

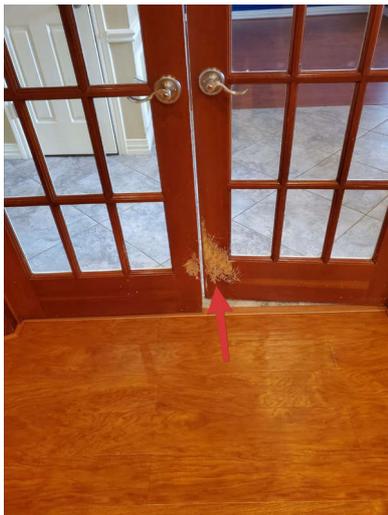
2: Paint/Refinish Needed

Door finish is worn. Recommend refinish and/or paint to maximize service life.

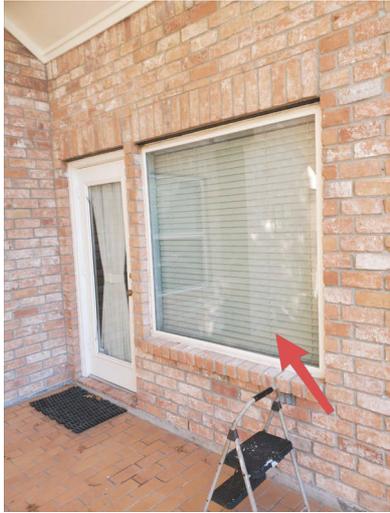
1: Safety Glass Required

Tempered safety glass is required at this location. Having glass that is not tempered at this location could lead to severe injury or possibly death if the glass were to shatter or if someone fell through this window. Recommend replacing this window with tempered safety glass immediately.

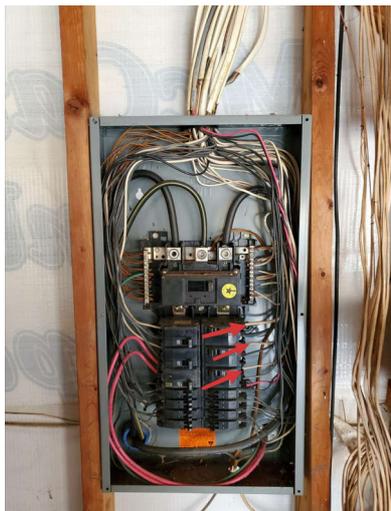
White wire used as hot power wire:

Multiple white wires were used as power supply wires from breakers. While this is not forbidden, the white wires are supposed to be taped or marked black or red to avoid any confusion. These wires should be taped or colored appropriately to help avoid any accidents in the future.

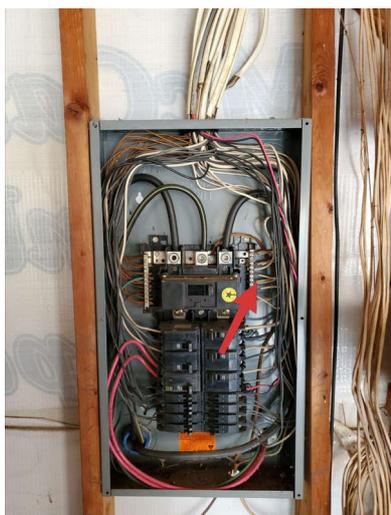
1: Double-Tapping of Neutral Wires

Double tapping of neutral wires is not allowed. Double tapping refers to having multiple neutral wires secured into the same neutral terminal. Today's standards require each neutral conductor (wire) have it's own neutral terminal connection.

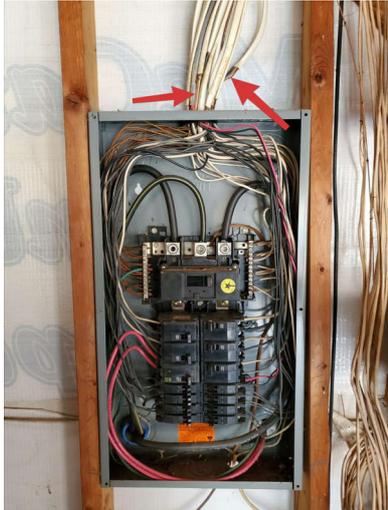
2: Frayed Sheathing

Wires on service entrance are damaged or frayed. Recommend contacting your electric utility company or a qualified electrician to evaluate and repair.

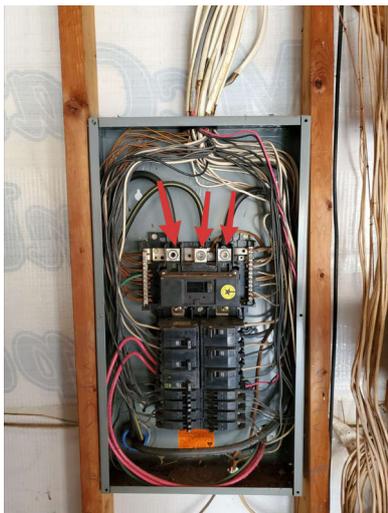
3: Anti-Oxidant Grease not Present

Anti-oxidant paste is required on aluminum wire ends to prevent oxidation and corrosion. If aluminum wire ends are not protected by this paste, the corrosion that results could result in a poor connection.

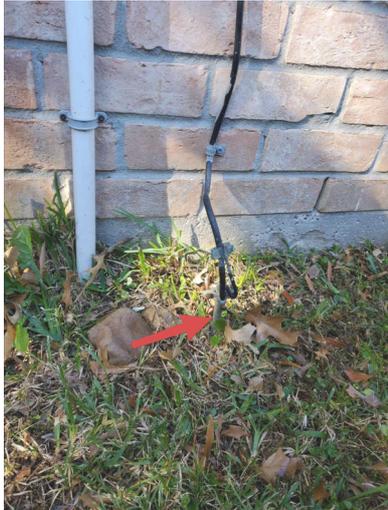
4: Ground rod not driven flush with ground.

Grounding rods are required to be driven flush with the ground. A ground rod that is sticking up presents a trip hazard along with the possibility of not providing a safe path back to ground for electricity. This could potentially result in a shock hazard.

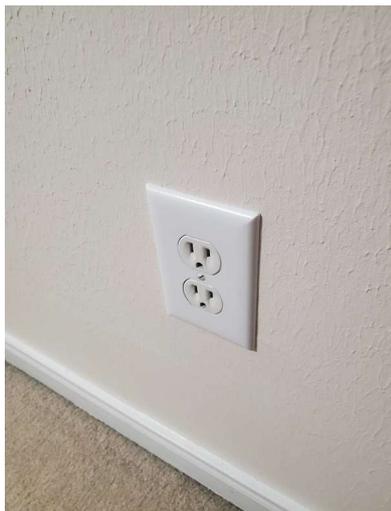
Multiple outlets throughout the house had an **Open ground**. This means there is no protection at the outlet providing a safe path back to ground for electricity. Multiple outlets were observed to be improperly secured and were easily moved when plugs were inserted and removed.

Loose outlet in dining room

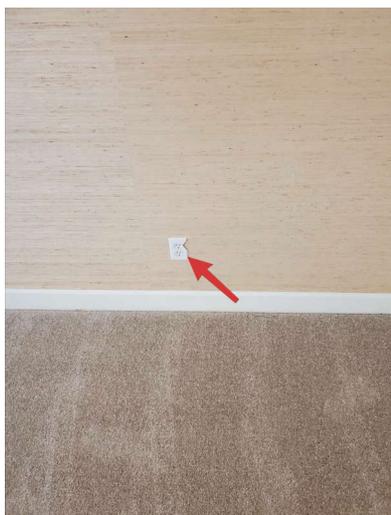
1: Cover Plates Damaged

One or more receptacles have a damaged cover plate. Recommend replacement.

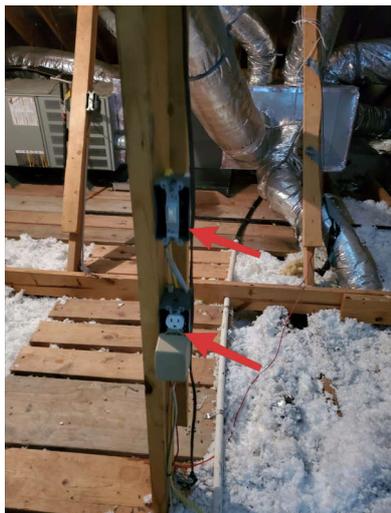
2: Cover Plates Missing

One or more receptacles are missing a cover plate. This causes short and shock risk. Recommend installation of plates.

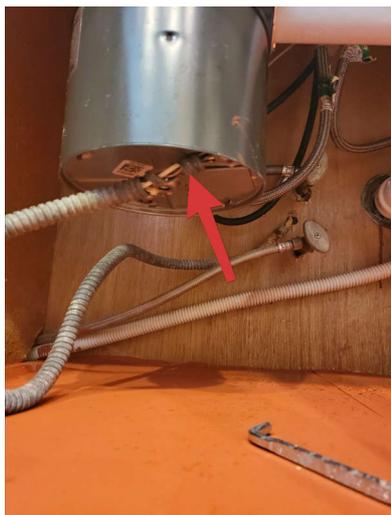
3: Exposed Ends & Splices

All wire connections & charged wires should be concealed. The wiring for the food waste disposer was not secured to the disposer with a wire nut and the conduit was damaged.

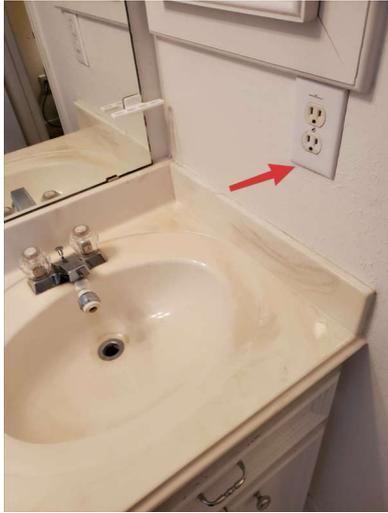
4: No GFCI Protection

No GFCI protection present in required locations. Recommend licensed electrician upgrade by installing ground fault receptacles in all locations.

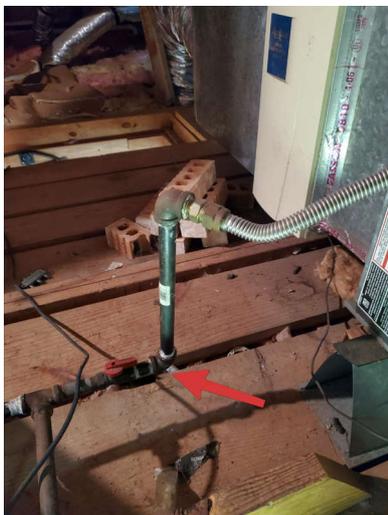
The gas piping contained no sediment trap. Sediment traps or drip legs are generally required, depending on your local jurisdiction. The purpose of a sediment trap is to prevent particulates or moisture from entering and clogging the furnace gas supply, which could trip the furnace and possibly lead to an expensive service call. We recommend consulting a local licensed, qualified HVAC technician concerning sediment trap installation. This is a cheap way to help avoid potentially costly repairs in the future.

Missing sediment trap

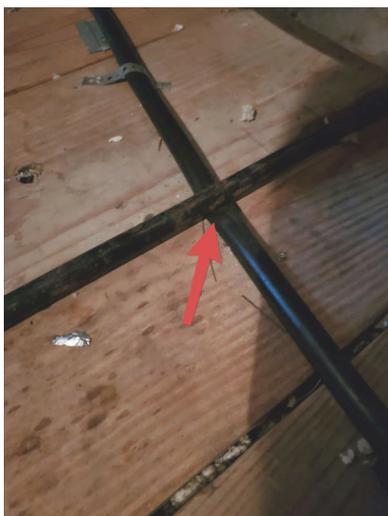
There was water standing in the secondary drain pan along with debris. In the event the evaporating unit primary drain completely plugs and leaks into the secondary drain pan, the debris can easily clog the secondary drain, leading to an overflow of the pan and damage to the ceiling below. Also, the secondary drain line was pinched down by gas supply piping laid on top of it, which could also result in an overflow of the drain pan if the primary drain ever fails. We recommend a licensed, competent HVAC technician repair this issue.

Pinched secondary drain line

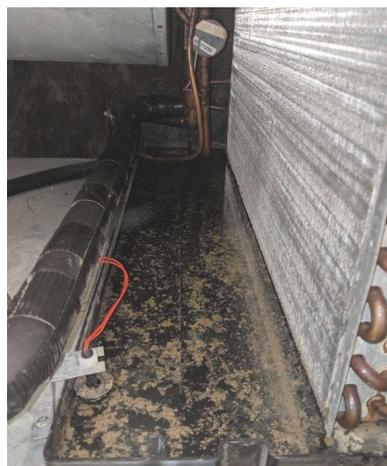
Dirty pan with standing water

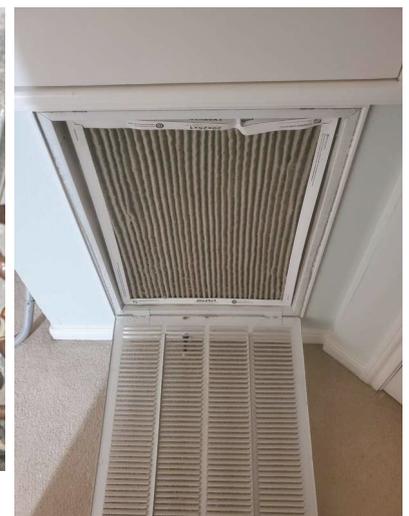
Hallway air filter size 20×25. Needs replacement

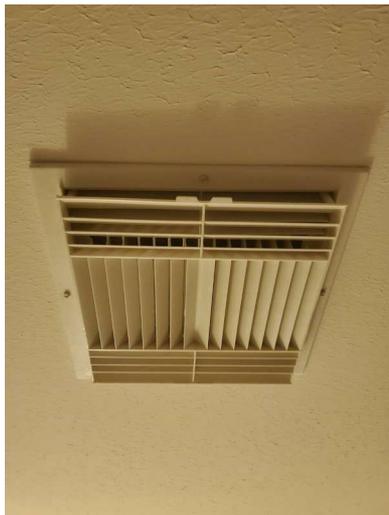
An active air vent was located on the ceiling of the garage. Modern building codes do not allow air vents to be in the garage as this could lead to fuel/exhaust fumes making their way into the house. We recommend repairing this issue.

Vent in garage

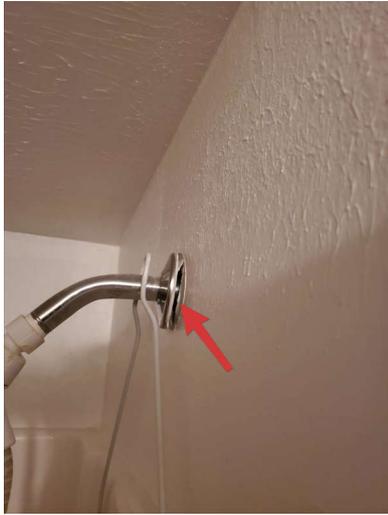
Shower heads were not caulked at walls as required. This can lead to water getting behind the wall, causing damage.

Needs caulk

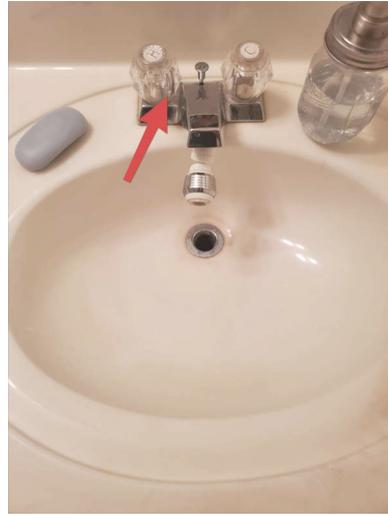
There was no hot water supplied to the master bathroom, only cold water. No water was connected to the hot side of the sink. Recommend having a plumber determine why there is no hot water being supplied and fix the issue.

No hot water

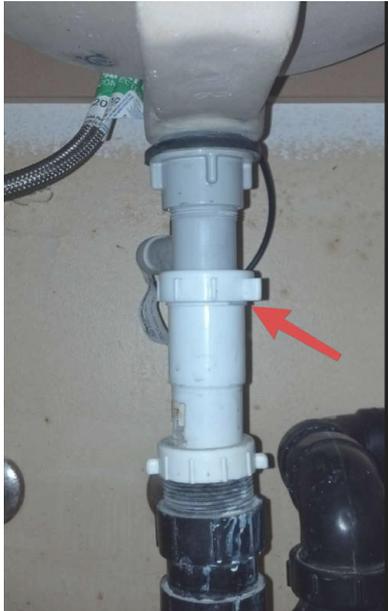
One leak was found under the master bathroom sink on the drain stem.

Leaking master bathroom sink

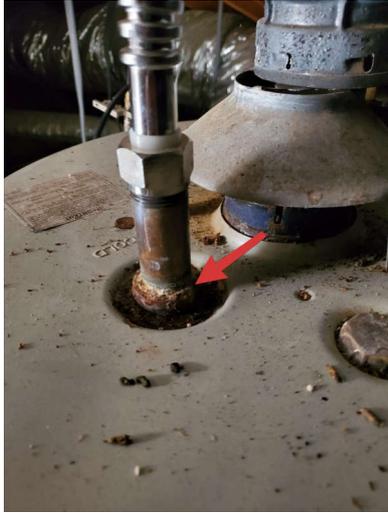
There was corrosion noted on the water heater piping connections, which can lead to leaks. The exhaust flue was not properly aligned which will let exhaust gases into the attic, instead of carrying them out through the roof.

Corrosion

Due to several issues being found around the hot water system, I recommend having a licensed plumber evaluate the system and correct the deficiencies listed in this report.

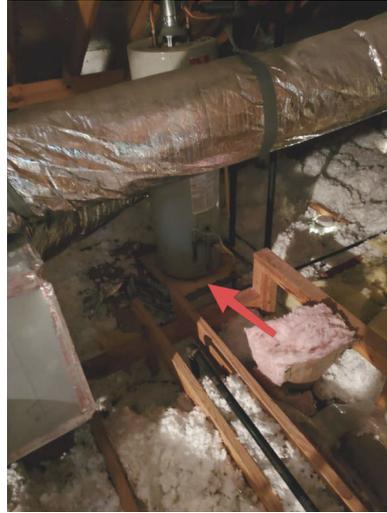
The drain pan was rusted and the water heater was placed in a position where future maintenance/replacement will be difficult. There was no work space or pathway provided to the water heater as required.

Rusted pan and water heater placed in cramped location

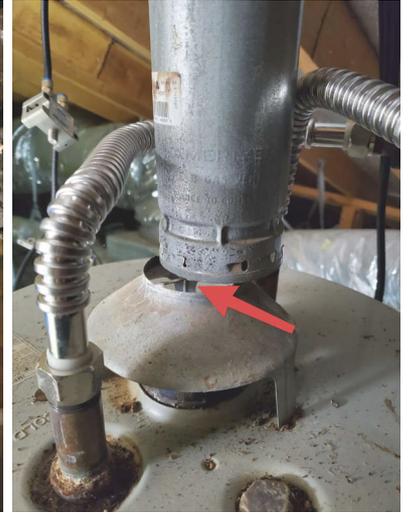
Flue not aligned properly

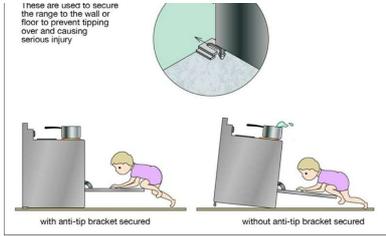
There was no anti-tip device installed on the back of the range, this could lead to the unit potentially toppling over if it is leaned on or if a child attempts to climb up the front. Unfortunately, children have been seriously injured and killed as a result of accidents like this. Anti-tip devices are cheap and easy to install. I recommend installing this device.

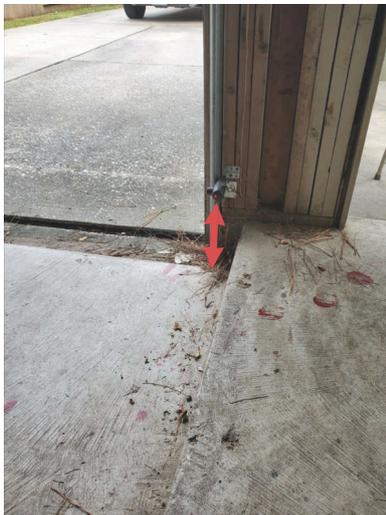
Auto- reverse sensors are required to be a maximum of 6 inches off of the floor. Children could potentially be crushed if they were lying down under the path of the door. The sensors are too high to detect small children or pets under the sensors. Recommend moving sensors lower.
