RESIDENTIAL INSPECTION

123 Main St
Houston TX 77001

John Doe
DECEMBER 9, 2019

PROPERTY INSPECTION REPORT

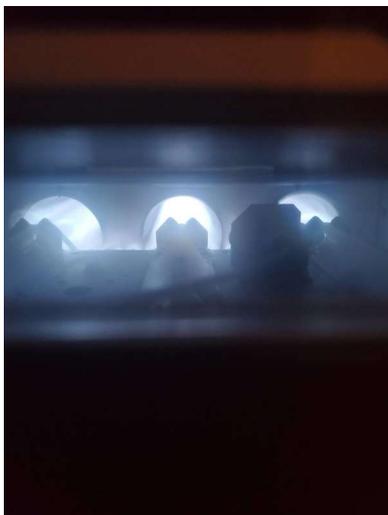
The equipment responded to operating controls at the thermostat when placed in the heating mode. Warm air was discharging from all supply air registers. All of the burners appeared to be functioning as intended as shown in the attached photos and video.

Burners firing appropriately

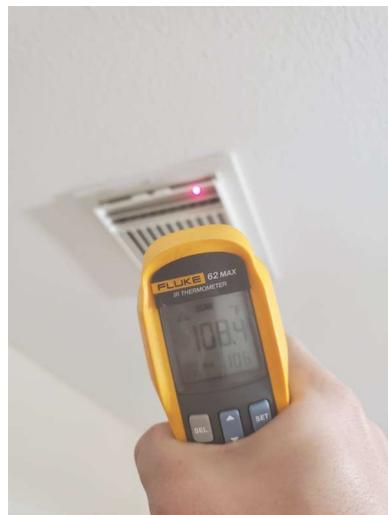
Warm air

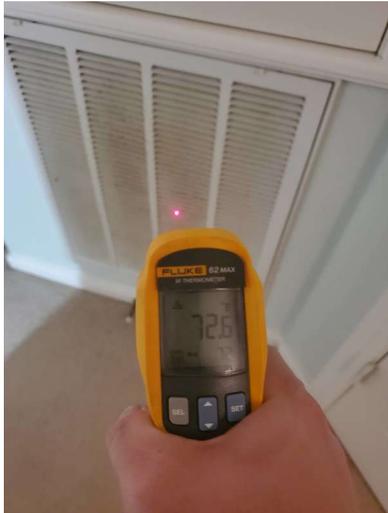
The temperature differential for this system was approximately 20 degrees.

Return air

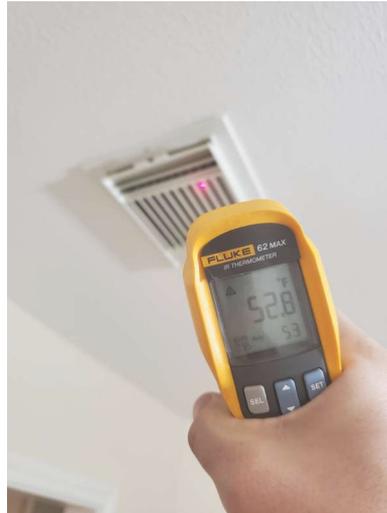
Supply air

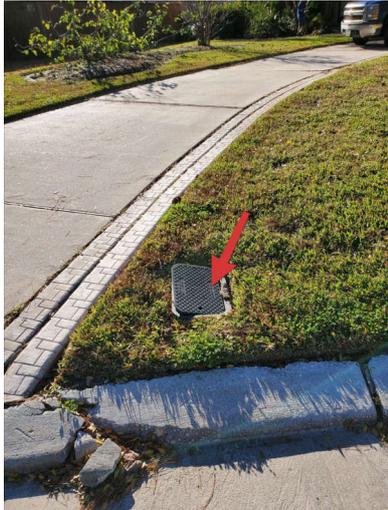
Location of Main Water Supply Valve : Main Level -
The main water supply valve is located on the left side of the house.

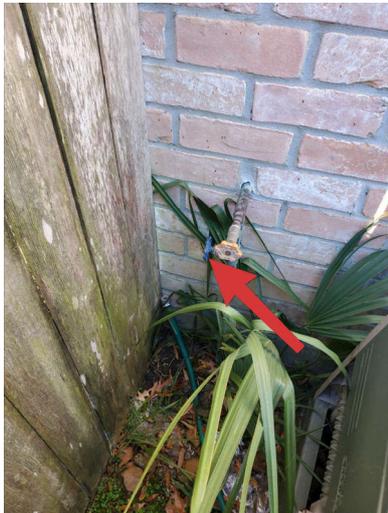
Static Water Pressure Reading: 58 -
Home static water pressure was within the acceptable range of 40-80 PSI at the time of this inspection.
